# Manhole Inspection Summary

Manhole # S23C1\_006MH

**Location** Address: **2507 Huron St**

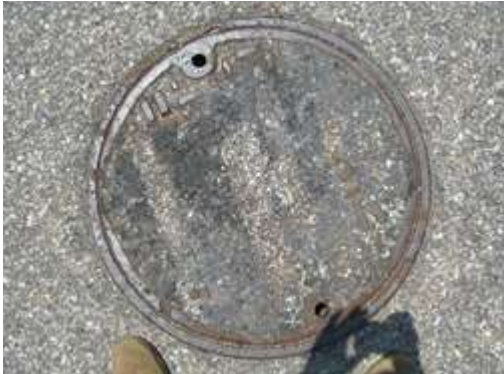
Miscellaneous

MH Cover pic

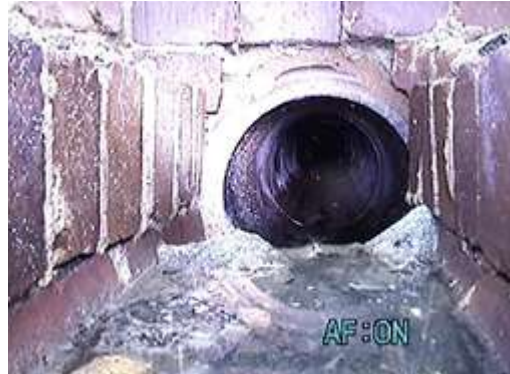
Defect 1

Condition: ☐ Sound ☐ Cracked ☐ Root Intrusion ☐ Deteriorated ☐ Leaks ☒ **Debris**

debris in channel 12:00 view

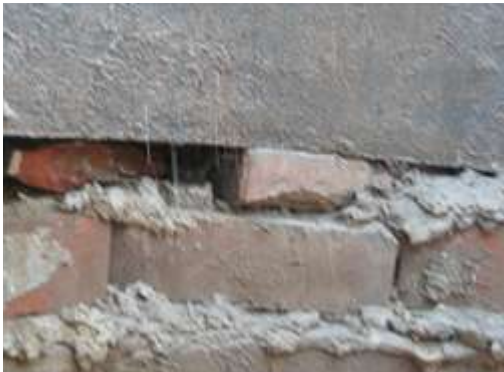
Defect 6

Condition: ☐ Sound ☐ Cracked ☐ Root Intrusion ☒ **Loose Brick** ☐ Deteriorated

Infiltration: ☐ None ☒ **Joint** ☐ Cracks ☒ **Mortar** ☐ Roots ☐ Wall

chimney loose/missing bricks with signs of infiltration at mortar & joint

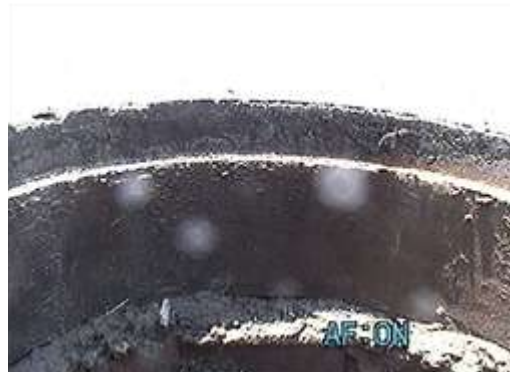
Defect 4

**Frame** Offset: **2** (in.) Condition: ☐ Sound ☐ Cracked ☒ **Leaks**

lid frame infiltration

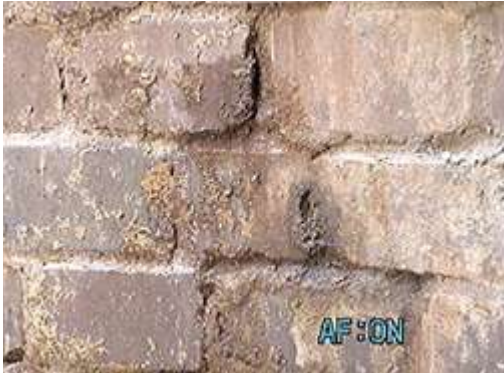
Defect 3

Infiltration: ☐ None ☐ Joint ☐ Cracks ☒ **Mortar** ☐ Roots ☐ Wall

barrel infiltration at mortar

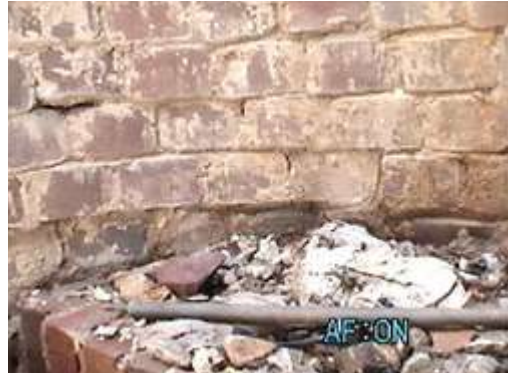
Defect 2

Condition: ☐ Sound ☐ Cracked ☐ Root Intrusion ☐ Deteriorated ☐ Leaks ☒ **Debris**

bench debris

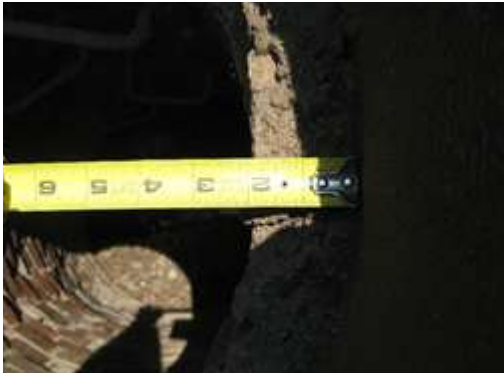
Defect 5

frame offset

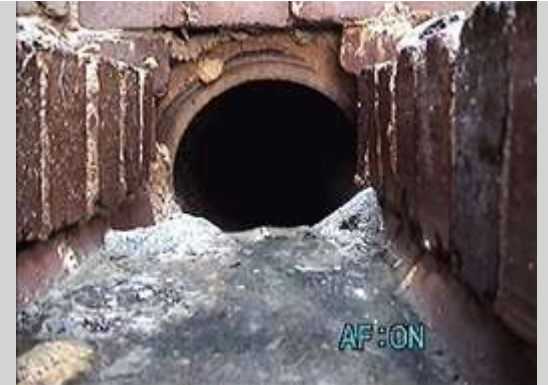
12 O'Clock Outflow

Pipe Height: **8.4** (in.) Rod and Bar (Angled)  
Pipe Material: **Clay** ☐ Pipe Lined  
Invert Depth: **8.54** (ft.) Flow Characteristics: **Fast**  
Deposits: ☒ None ☐ Mud ☐ Sludge ☐ Debris ☐ Grease  
Silt Depth: **0** (in.) Deposits Extent:  
Infiltration: **None** Pipe Seal Cond: **Sound**

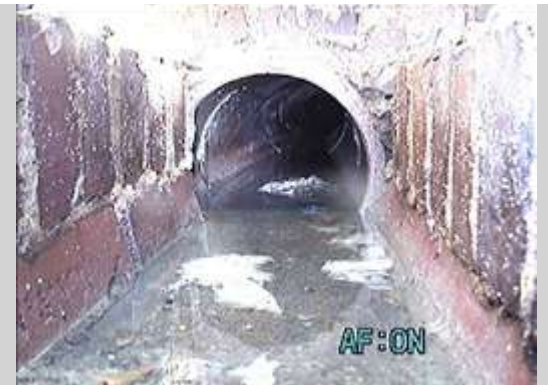
6 O'Clock Inflow

Pipe Height: **8.4** (in.) Rod and Bar (Angled)  
Pipe Material: **Clay** ☐ Pipe Lined  
Invert Depth: **8.47** (ft.) Flow Characteristics: **Slow**  
Deposits: ☒ None ☐ Mud ☐ Sludge ☐ Debris ☐ Grease  
Silt Depth: **0** (in.) Deposits Extent:  
Infiltration: **None** Pipe Seal Cond: **Sound**
